Pyplok® Case Study: **Removal and Repair of Clogged Deck Drain Line**

Location of the project : **Shell Sarawak Berhad– E11 Complex**

Scope of Work : **Removal and Replacement of Clogged E11P-A Deck Drain Lines and to install new Pyplok® fittings**

Piping Specs : **4”NPS Carbon Steel Line**

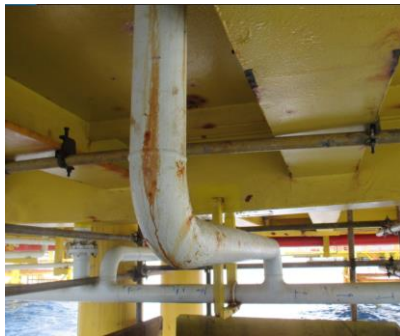
Identifying the pipe to be cut

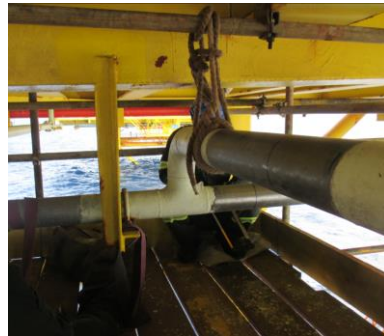
Surface Preparation to bare Metal

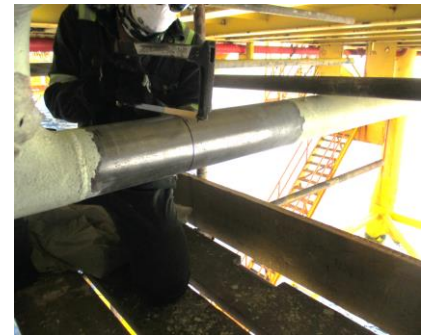
Cutting the pipe with hack saw

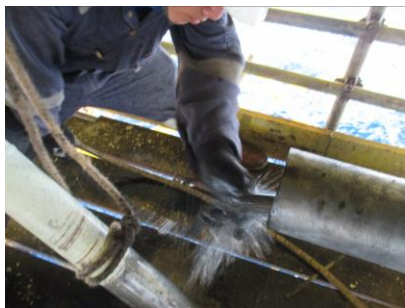
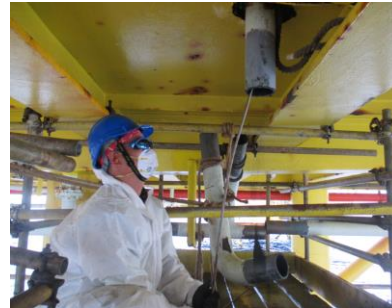
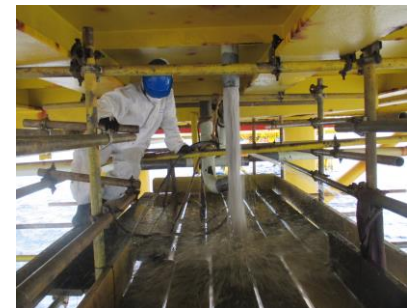
2. De-clogging the line

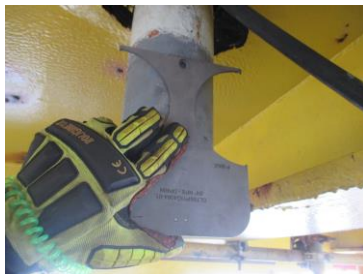
Marking on the pipe

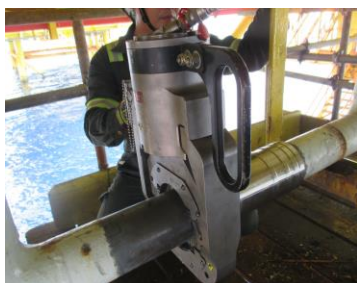
Crimping the Pyplok®

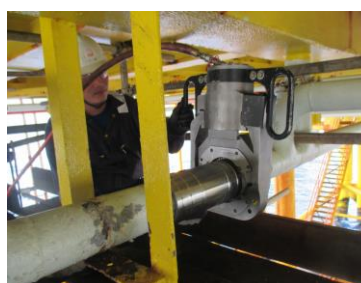
Crimping the Pyplok®

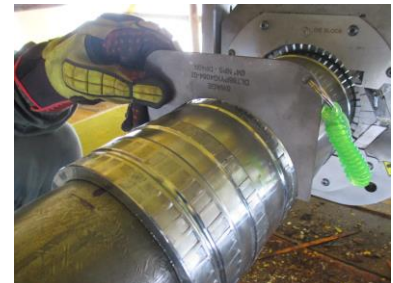
Swage Dia Inspection

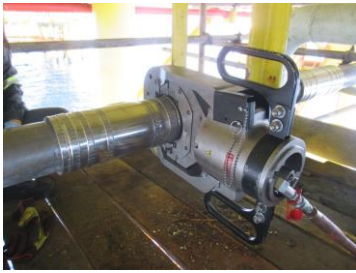
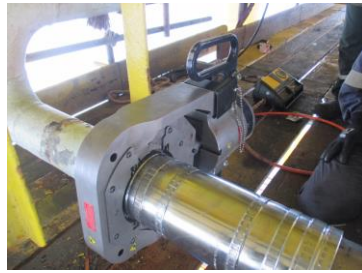
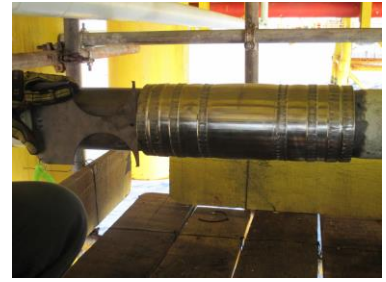
Secondary Marking Inspection

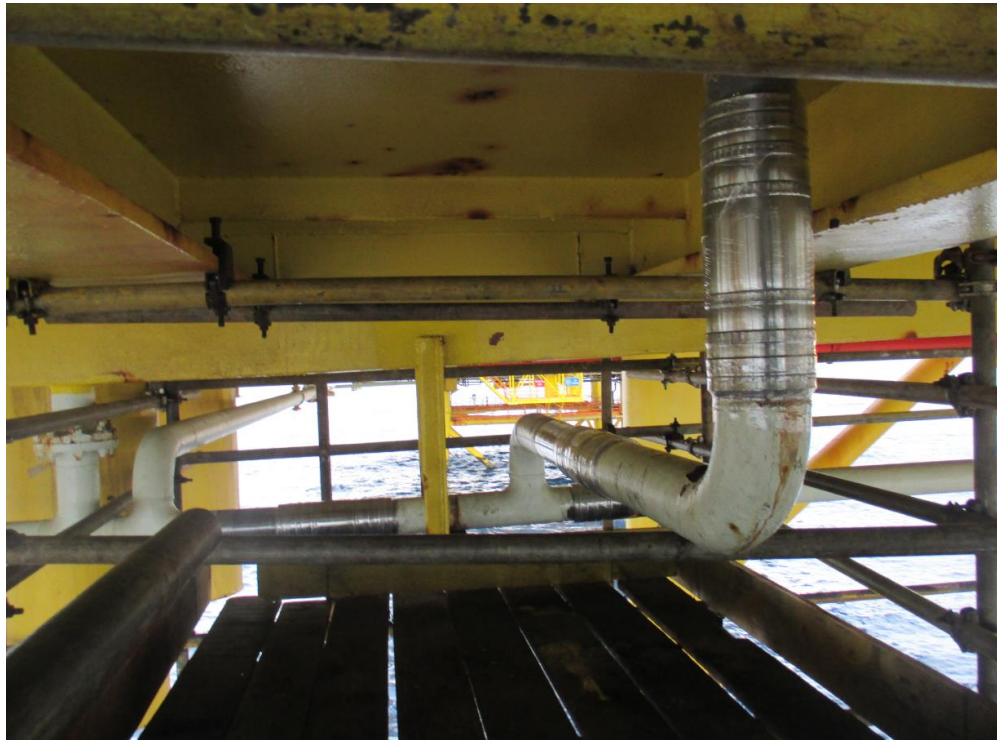
View of the Installed Pylok® Fitting
